**CAPSULE SUMMARY**  
**BA-3072**  
**House, 7524 Marks Avenue**  
**Overlea, Baltimore County**  
**ca. 1904**  
**Private**

## Maryland Inventory of Historic Properties Form

Inventory No. BA-3072

Name House, 7524 Marks Avenue, Baltimore  
**Continuation Sheet**

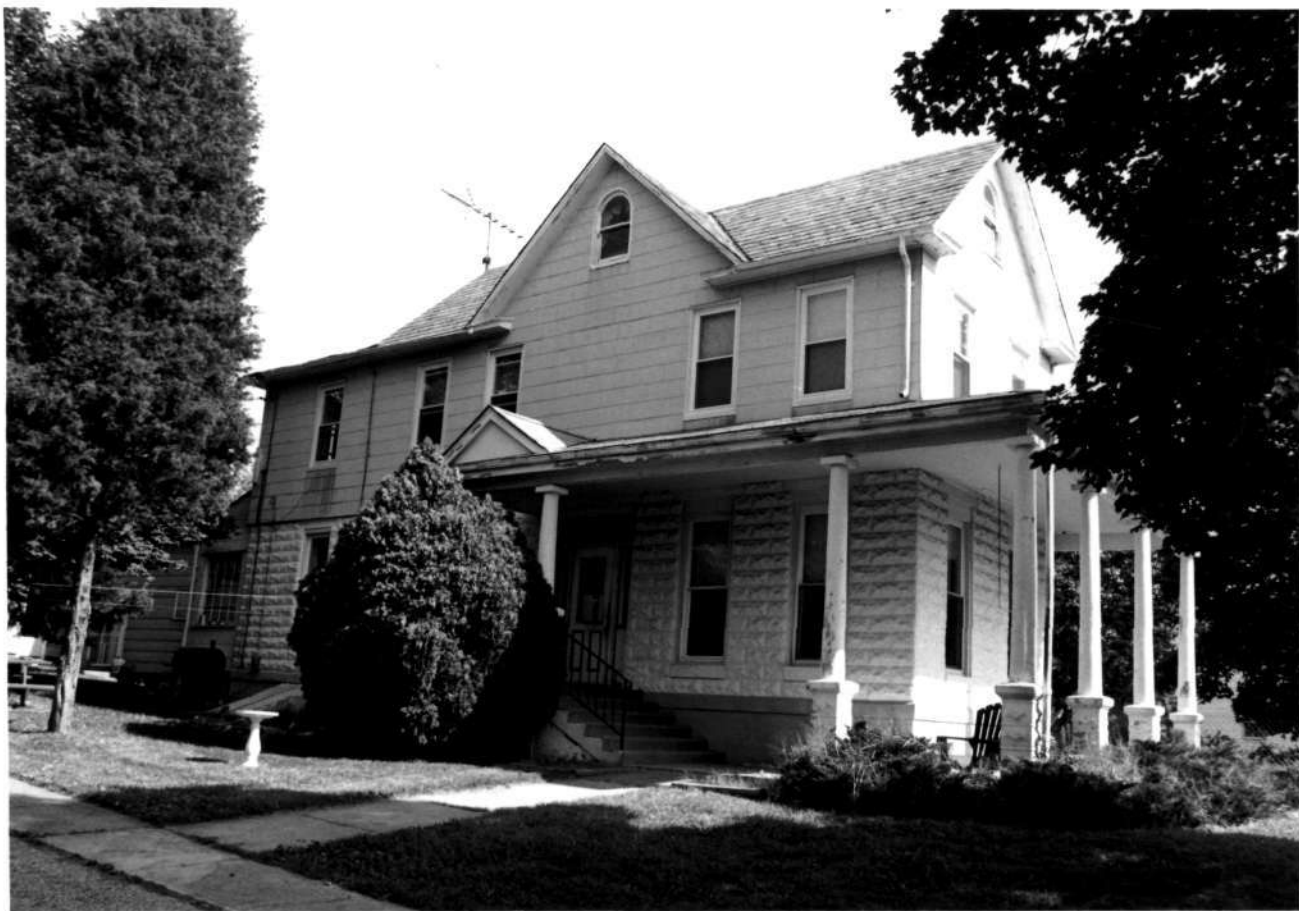
1 OF 5

PRIMARY FACADE, LOOKING NORTH

The southwest elevation, reading as the primary façade, is marked by the wrap-around porch, central entry opening, open pedimented gable, and ell on the northwest elevation. The central entry, accessed via concrete stairs, is slightly recessed within the plane of the wall. This opening is raised above the foundation and square-edged watertable. The foundation is unfenestrated, save the metal bulkhead located just north of the wrap-around porch. The porch terminates to the north of the entry. The entry opening is surrounded by narrow sidelights of leaded glass set over recessed panels. It is finished with a leaded transom. The door, which appears to be a replacement, has multiple lights set over vertical panels. It is sheltered by a glass-and-paneled storm door. Flanking the entry, the original main block of the house is pierced by two sets of elongated window openings. The openings hold replacement 1/1 double-hung windows of metal set within cast concrete sills and lintels. These replacement windows are shorter and slightly narrower than the openings in which they sit. Consequently, the openings have been partially infilled and parged. The original wood surrounds, finished with a narrow interior bead, are extant. The single window opening in the ell is similarly finished with a replacement 1/1 double-hung, metal sash window with a cast concrete sill.

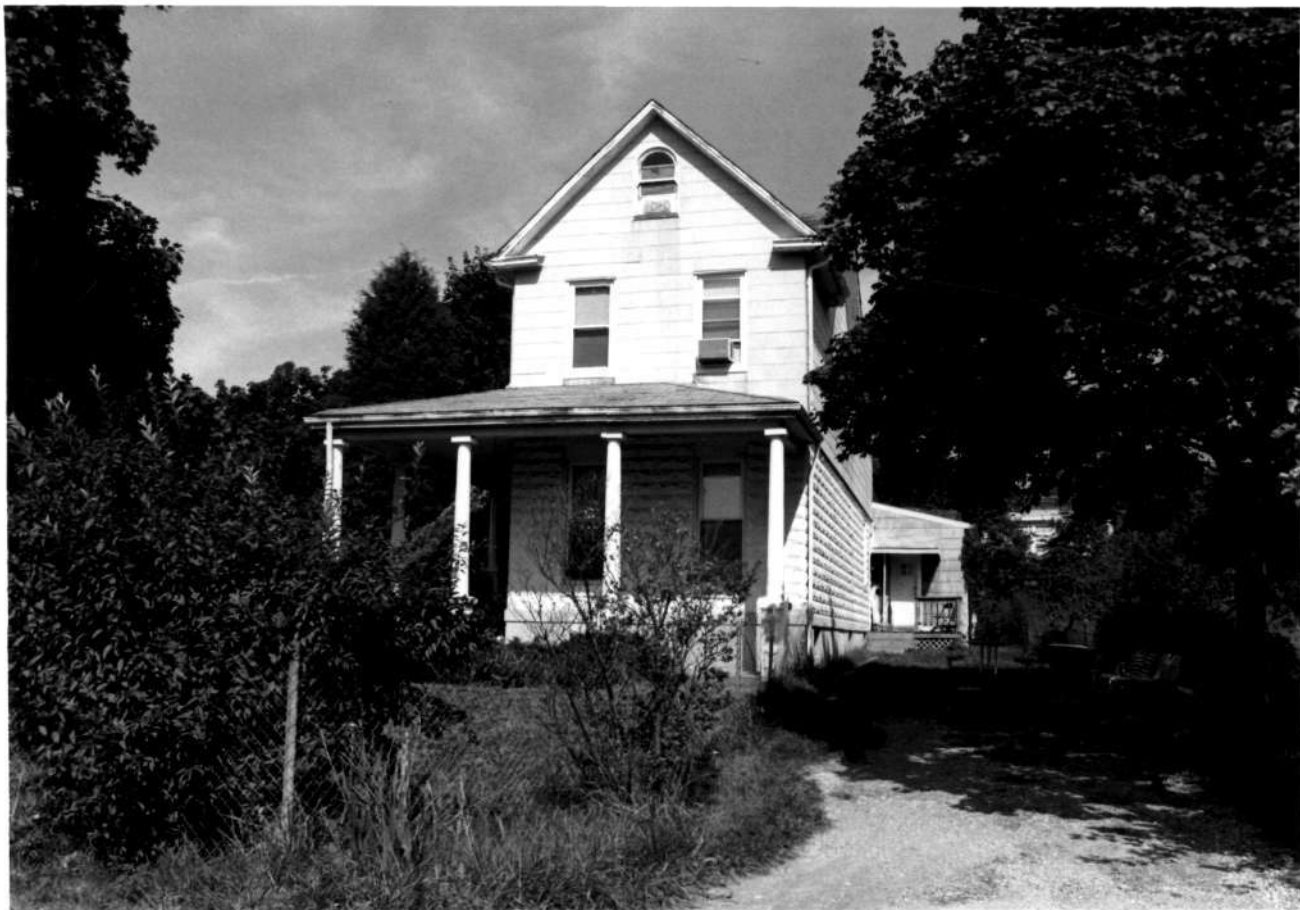
2 OF 5

SOUTHEAST ELEVATION

The southeast elevation fronting Marks Avenue is two bays wide and two-and-a-half-stories in height. A one-story wrap-around porch that turns the south corner of the building to the southwest elevation augments the first story of the building. The wood frame porch is composed of a poured concrete base with Tuscan columns. These wood columns are set on low rock-faced concrete bases with ogee-molded capitals. The columns support the half-hipped roof, which is clad with slate tiles. An enclosed pediment is located at the end of the porch on the southwest elevation, set directly over the primary entry into the dwelling. This pediment has a wood-clad tympanum with square-edged raking. The edge of the porch roof is finished with a recessed frieze, boxed entablature, and ogee-molded cornice. Access to the entry is gained via poured concrete steps edged by a metal rail. The steps are entered from the south side.

The first story of the southeast elevation, clad with rock-faced concrete blocks over the raised foundation of poured concrete, is pierced by two elongated window openings. The openings hold replacement 1/1 double-hung windows of metal set within cast concrete sills and lintels. These replacement windows are shorter and slightly narrower than the openings in which they sit. Consequently, the openings have been partially infilled and parged. The original wood surrounds, finished with a narrow interior bead, are extant. The second story is symmetrically pierced with two standard size window openings. The openings hold replacement 1/1 double-hung windows of metal. The late 20<sup>th</sup> century cladding of the second story has obscured the original sills, lintels, and casings. Thus, the openings are framed with an aluminum casing that is a component of the replacement windows. The gable end of the southeast elevation has a single semi-circular arched window opening. This small opening retains the original 1/1 double-hung, wood sash window with wood sill and beaded surround.

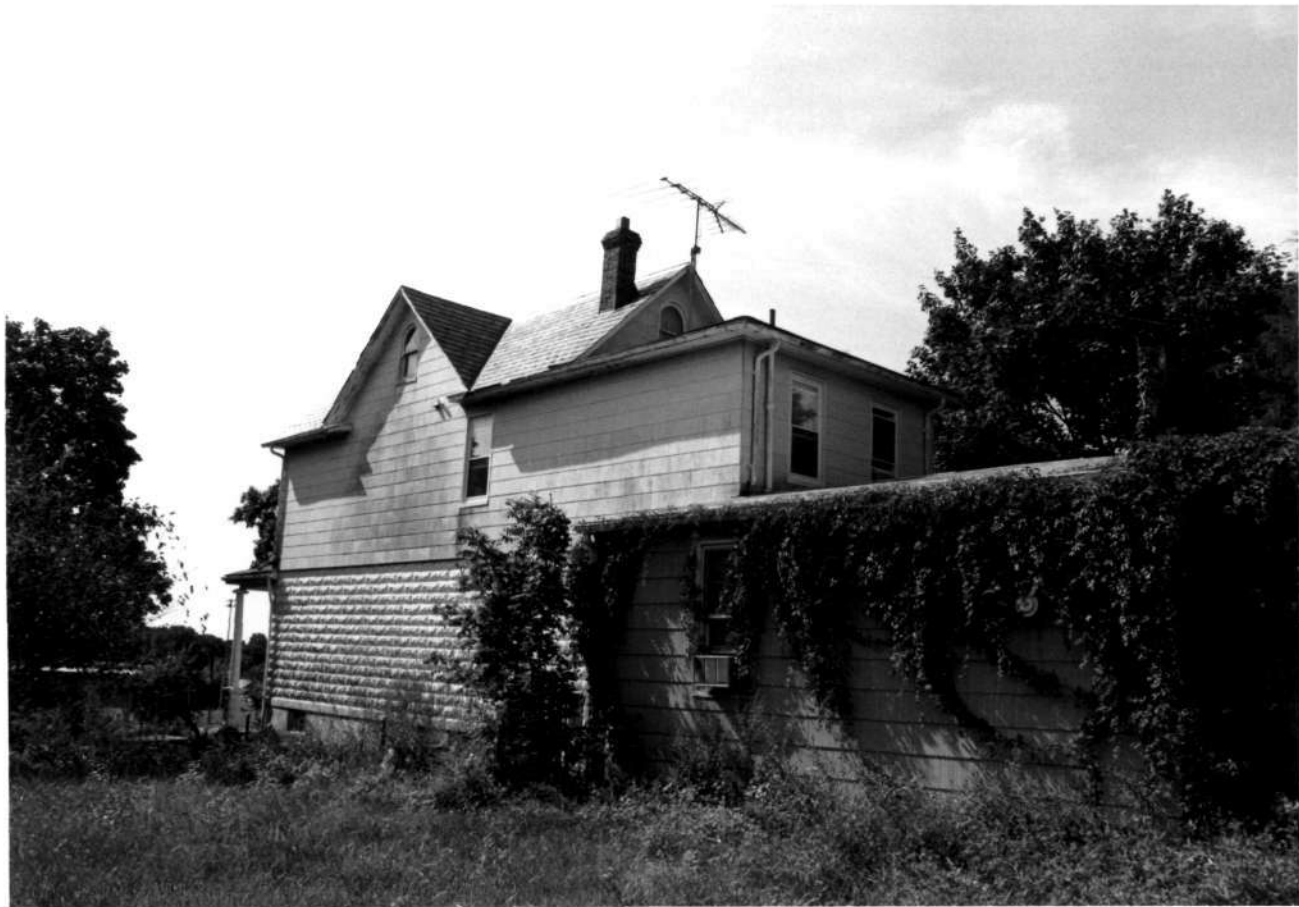
4 OF 5

NORTHEAST ELEVATION, LOOKING SOUTH

The northeast elevation is largely devoid of openings, rather it clearly presents the materials in which the building is constructed and clad. The raised foundation of poured concrete is pierced by three deeply recessed openings. The rectangular openings hold two-light fixed windows of metal. Constructed of rock-faced concrete block, the first story of the main block has no openings. The ell, however, is pierced on the first story by a single window opening. This opening holds a replacement 1/1 double-hung, metal sash window with a cast concrete sill and lintel. The second story of the main block, which is clad with asbestos shingles, is pierced by one replacement 1/1 double-hung window of metal. Within the open gable of the centrally placed pediment is a small 1/1 double-hung, wood sash window set in a semi-circular arched opening. This opening retains the original wood sill and beaded surround.

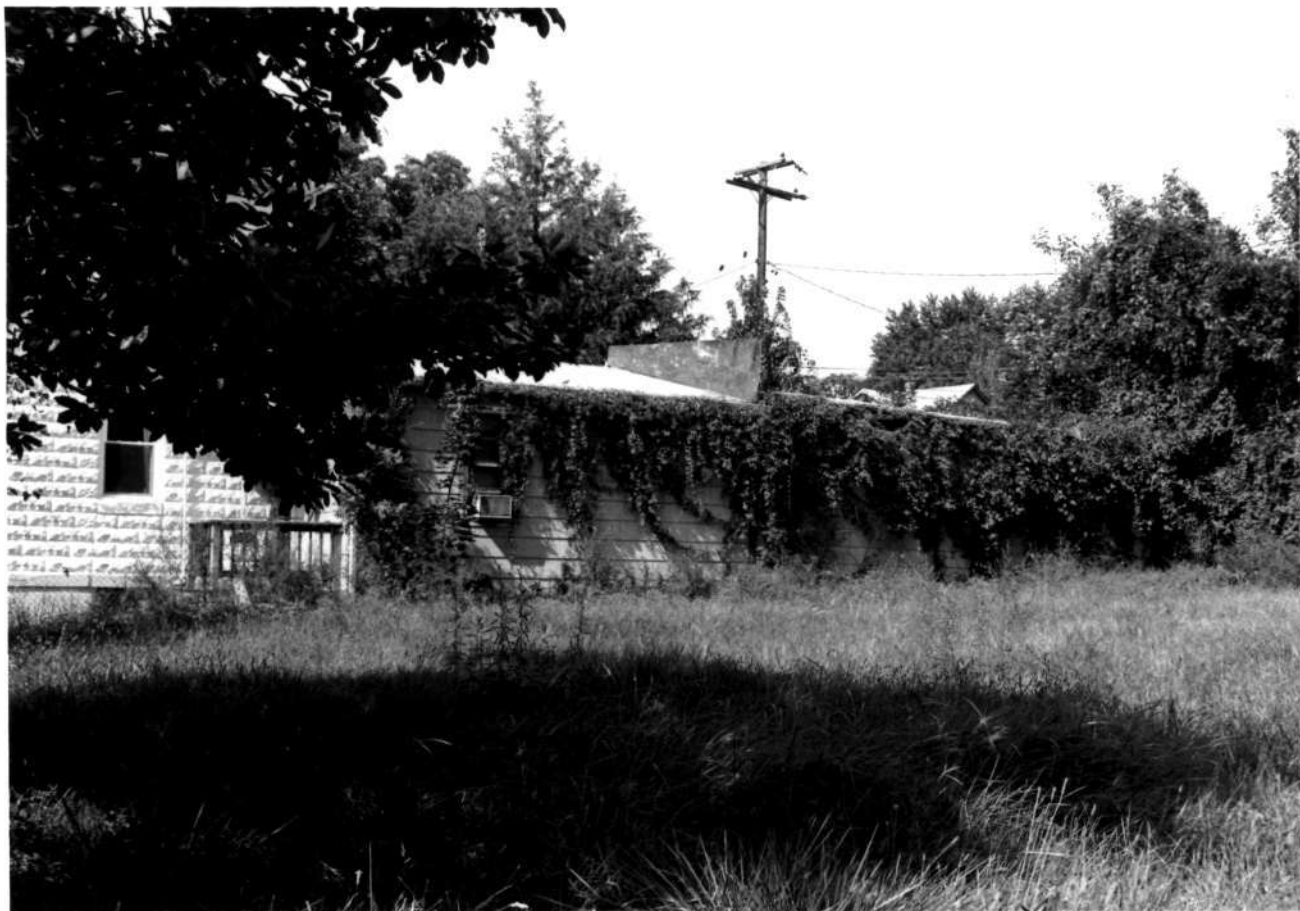
5 OF 5

CHICKEN COOP/BARN, LOOKING WEST

The one-story attached apartment structure on the north corner of the building was originally used as a chicken coop. Constructed of wood frame, this structure is covered by a shed roof clad with asphalt shingles. The overhanging eaves of the roof shelter the asbestos shingle cladding of the building. It is pierced on the southeast side by a single entry opening holding a multi-light wood door. The opening is set under a shed roof pediment, clad with corrugated metal sheets. A wood frame porch, dating from the latter part of the 20<sup>th</sup> century sits at the front of the entry. The northeast elevation of the two bay deep structure is partially obscured by ivy. There is a single opening holding a 1/1 double-hung, metal sash window with narrow surrounds. A similar opening pierced the northwest elevation of the structure. The northeast elevation of the former chicken coop is attached to the one-story garage, which originally was used as a barn. These two joined structures are separated by a brick party wall. The gabled garage is constructed of wood frame and extensively covered with ivy.
